# Jordan/Alder Watershed Assessment

February 2006

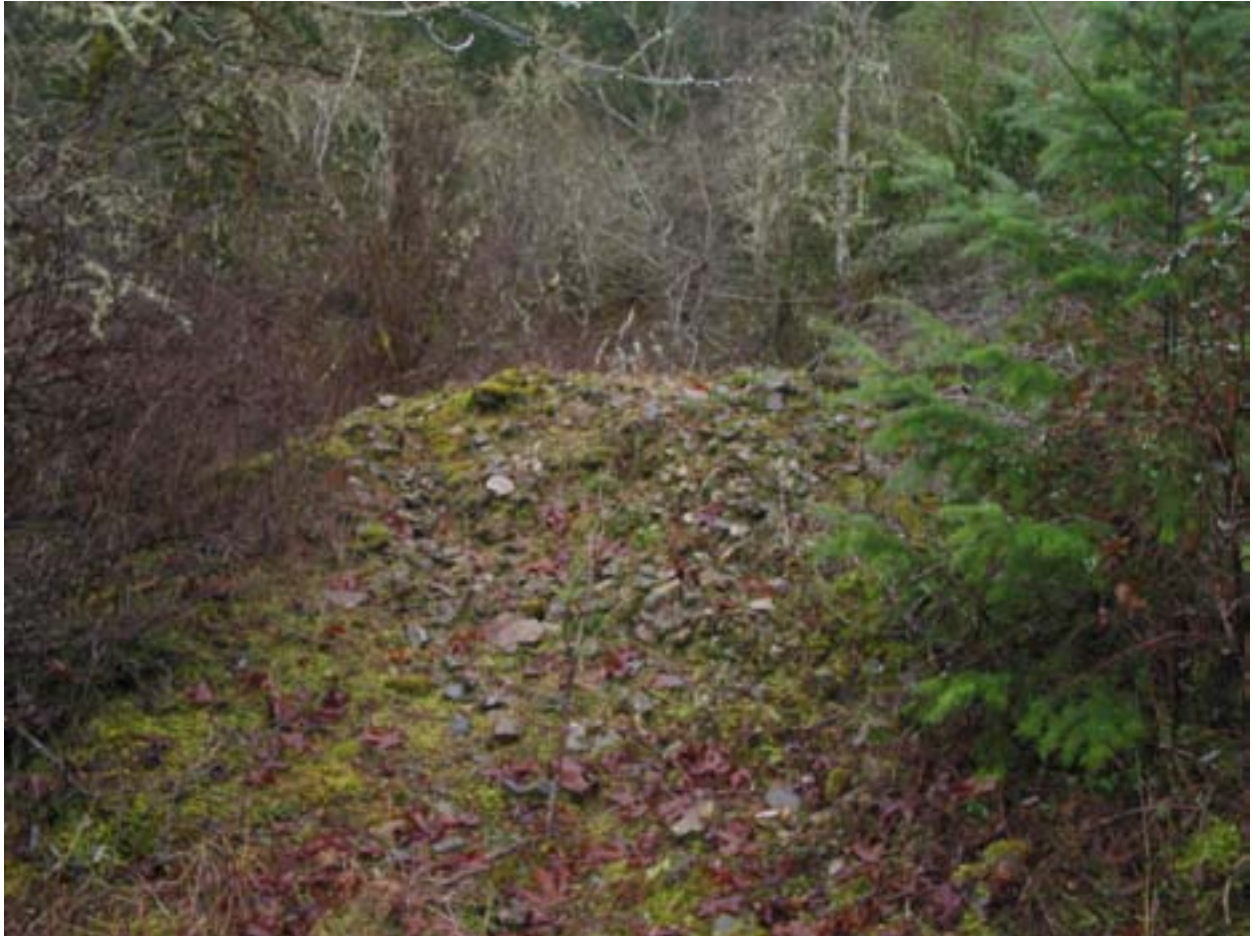
**Figure 12. Mine tailings on Jordan Creek south of the Canyonville-Riddle Road.**

In addition to the historical falls that serve as a fish passage barrier on upper Jordan Creek (as mentioned above), tailings from mining activity in the early 1900s obstruct fish passage on most of Jordan Creek in the south half of Section 32, T30S, R5W (this portion of Jordan Creek is south of the Canyonville-Riddle Road). Here, Jordan Creek streamflow goes subsurface in places, thus precluding further fish passage.

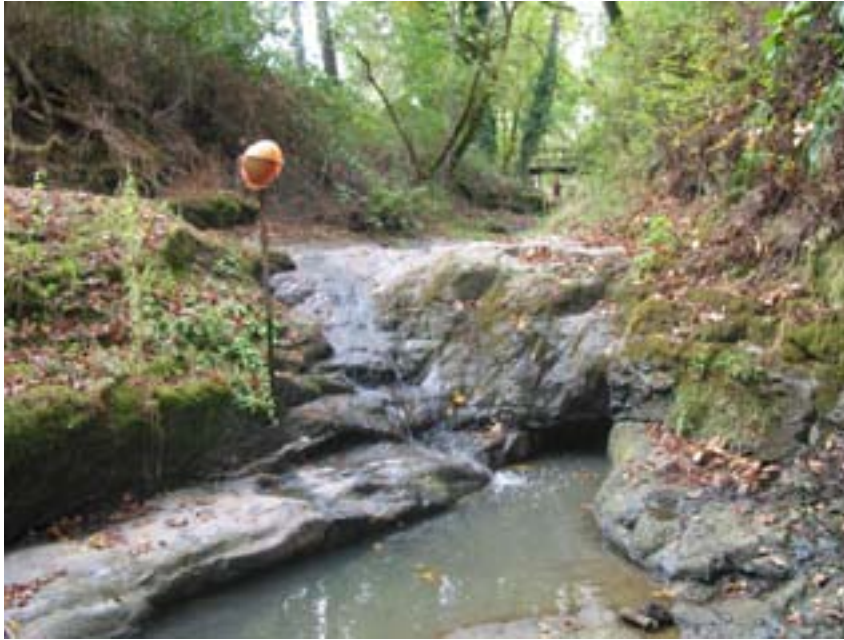
**Figure 17. Step upstream of mouth of Jordan Creek on October 6, 2005. Hard hat is resting on top of a six-foot metal fence post. Latitude/longitude: -123.29/42.9443.**

While this step may be a barrier to all life stages of fish at low streamflows, adult salmonids are able to pass through this point at higher streamflows (Bill Cannaday, ODFW Habitat Restoration Biologist, personal communication, November 14, 2005). As noted in Section 3.1.2, coho salmon have been observed at the Jordan Creek culvert under I-5, upstream of the step.

Bedrock comprises much of the Jordan Creek substrate below I-5. High streamflows through the I-5 culverts may have washed away gravel and other loose substrate material downstream of the culverts. The strategic placement of large boulders above and below the Jordan Creek step would return “roughness” to this part of the stream channel and facilitate fish passage upstream from the South Umpqua River.

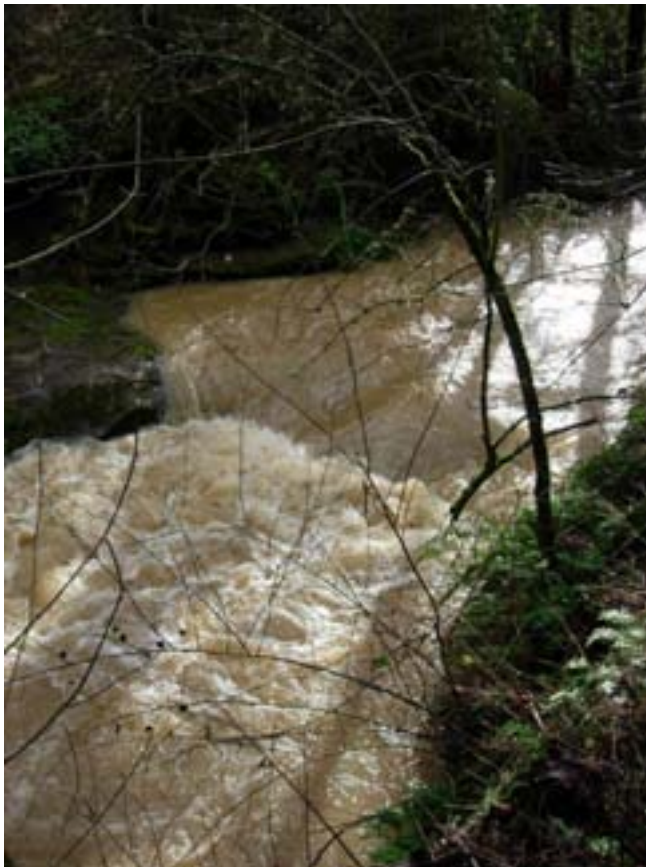
**Figure 18. Step upstream of mouth of Jordan Creek on January 1, 2006.**

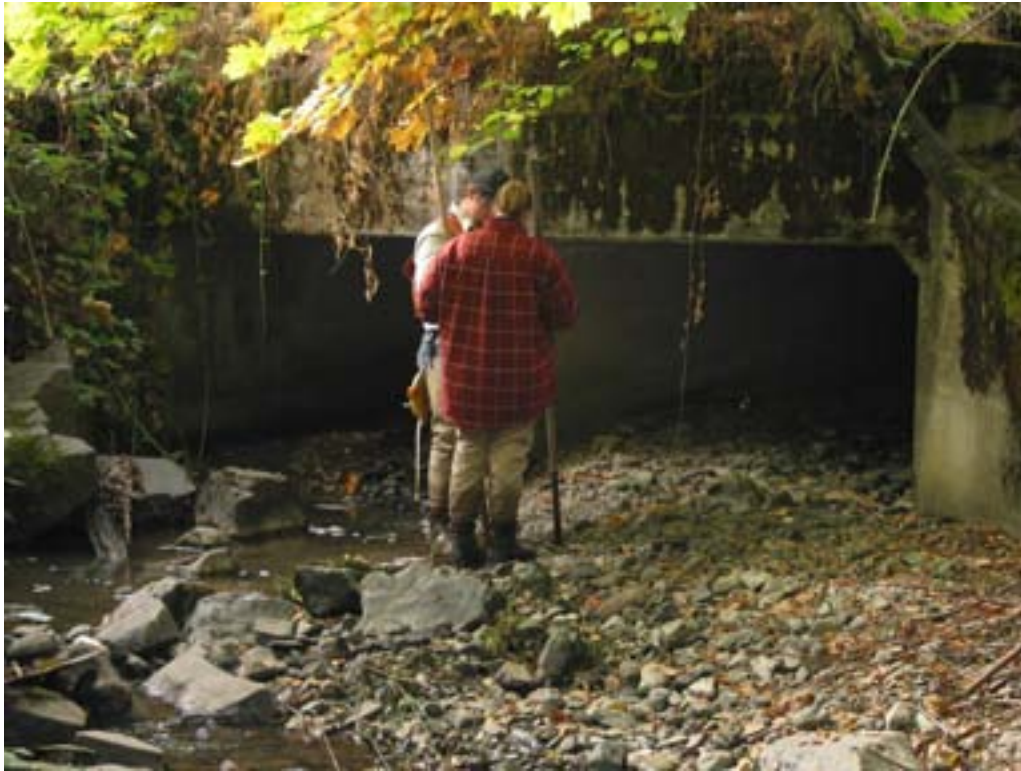
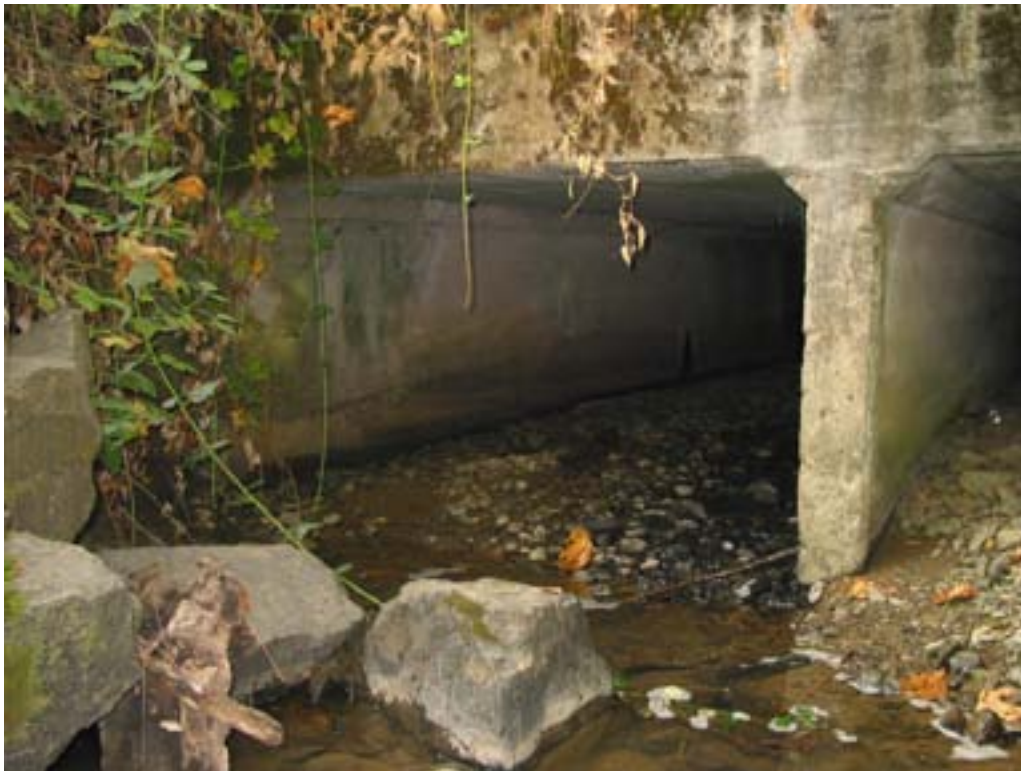
All of these culverts, except for culvert #7, are within ODFW's potential habitat range for coho salmon and winter steelhead as identified in Figures 13 and 14. The most limiting for fish passage of all culverts in the Jordan/Alder Watershed are the twin culverts through which Jordan Creek passes underneath I-5 and the frontage roads on either side of I-5, noted as culvert #1 in Figure 20 and Table 8. Here, Jordan Creek passes through twin reinforced concrete box culverts, each of which is approximately 360 feet in length. These culverts act as barriers because of the high streamflow velocity as water flows through these concrete "chutes." The lack of light within the culverts may also serve as a barrier to fish passage.

**Figure 21. Culvert #1 outlet on Jordan Creek at I-5.**

**Figure 22. Culvert #1 outlet on Jordan Creek at I-5 (south half of twin box culverts).**

There are ongoing discussions between the Tribe, Oregon Department of Transportation, and others regarding a fix for the I-5 culvert. Possible solutions include a replacement bridge, weirs or baffles inside the existing culverts to decrease stream velocity, skylights to provide natural light, and/or artificial lighting inside the culverts.

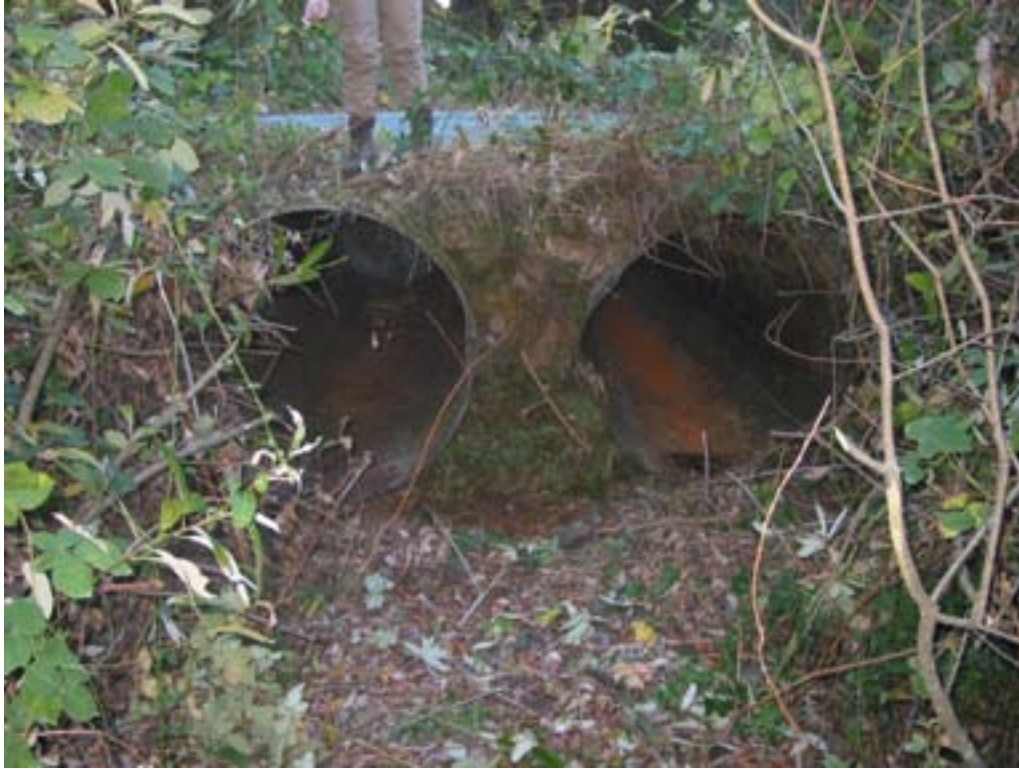
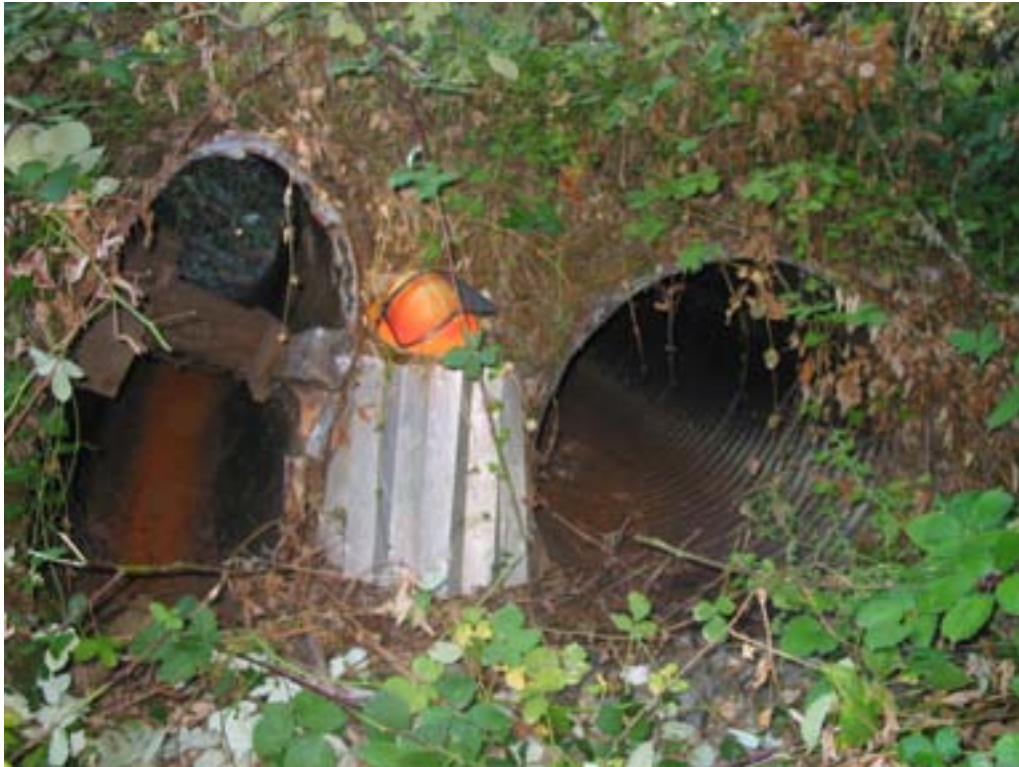
Four other culverts (culverts #1, 2, 6, and 11) are currently failing. One of the two corrugated metal pipes at culvert #2 is being flattened vertically. There is a “ram” inside this culvert to prevent it from collapsing. Anecdotal evidence suggests that this culvert began to fail during the 1996 high streamflow events. Culverts #6 and 11, also corrugated metal pipes, are rusting out and failing at their bottoms.

**Figure 23. Culvert #2 outlet on Jordan Creek at north end of Rod & Gun Club Road.**

**Figure 24. Culvert #2 inlet on Jordan Creek at north end of Rod & Gun Club Road.**

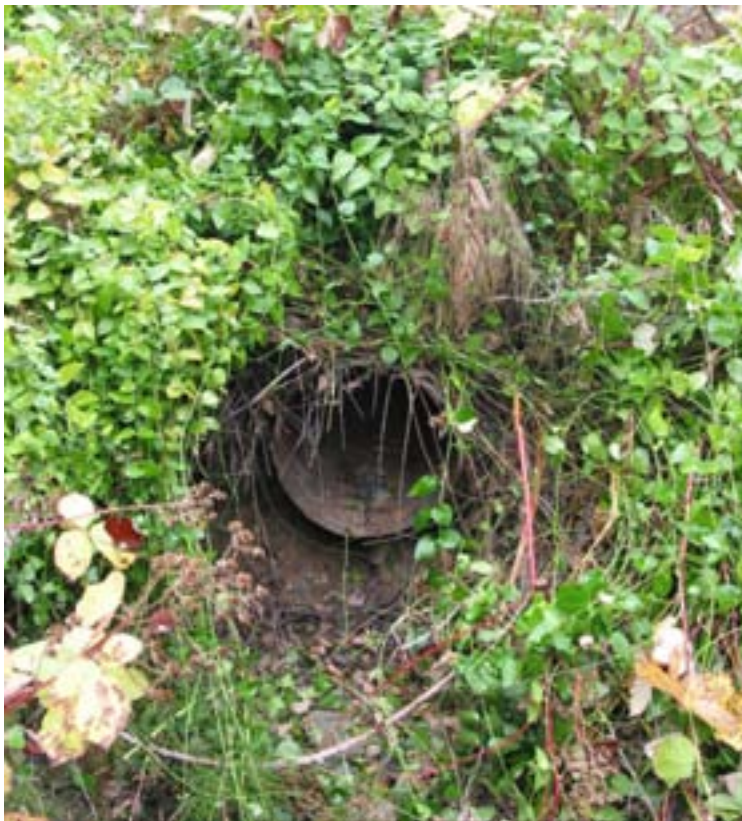
**Culvert Physical Condition.** Two of the 12 culverts (culverts #4 and 8) failed at some time in the past. These culverts may have failed during the high streamflows of the 1996 storm events. These two failed culverts are now only partially functional, with at least some of the water flowing around rather than through the culverts. Note that the two failed culverts have the lowest flow capacity relative to the 50-year and 100-year storm events. The original size of culvert #4 would allow it to carry 3% of a 50-year storm event and 2% of a 100-year event. Culvert #8 was sized to carry 17% and 12% of a 50-year and 100-year storm event, respectively. These culverts no longer serve the purpose of allowing for a road crossing of the streams.

**Figure 26. Culvert #4 outlet on Jordan Creek at washed-out road off Rod & Gun Club Road.**

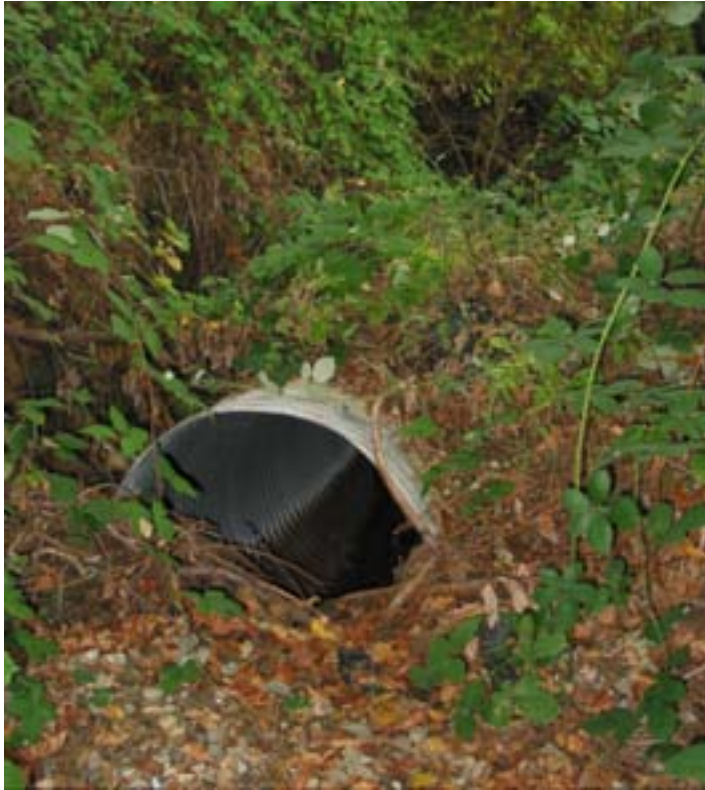
**Figure 31. Culvert #8 inlet on Alder Creek at washed-out road off Meyer Lane.**

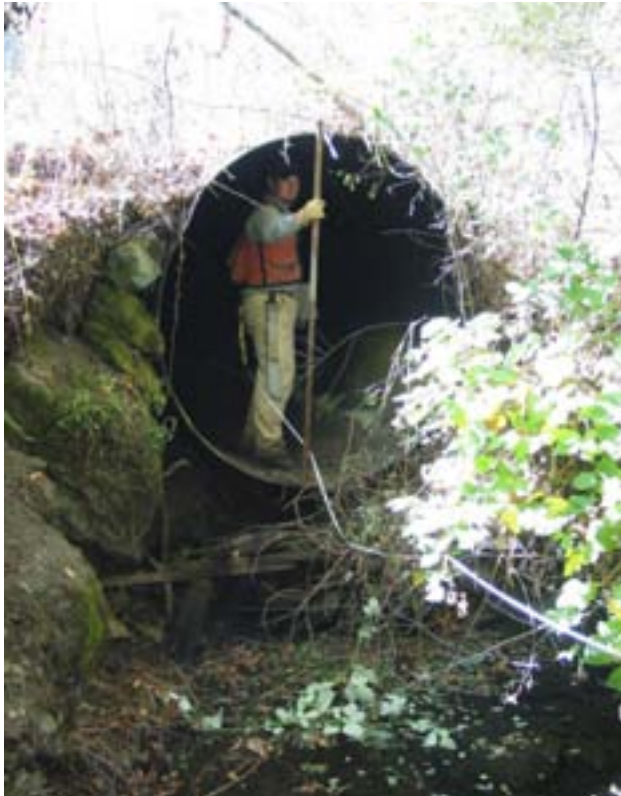
**Figure 34. Culvert #11 outlet on Alder Creek at Canyonville-Riddle Road.**

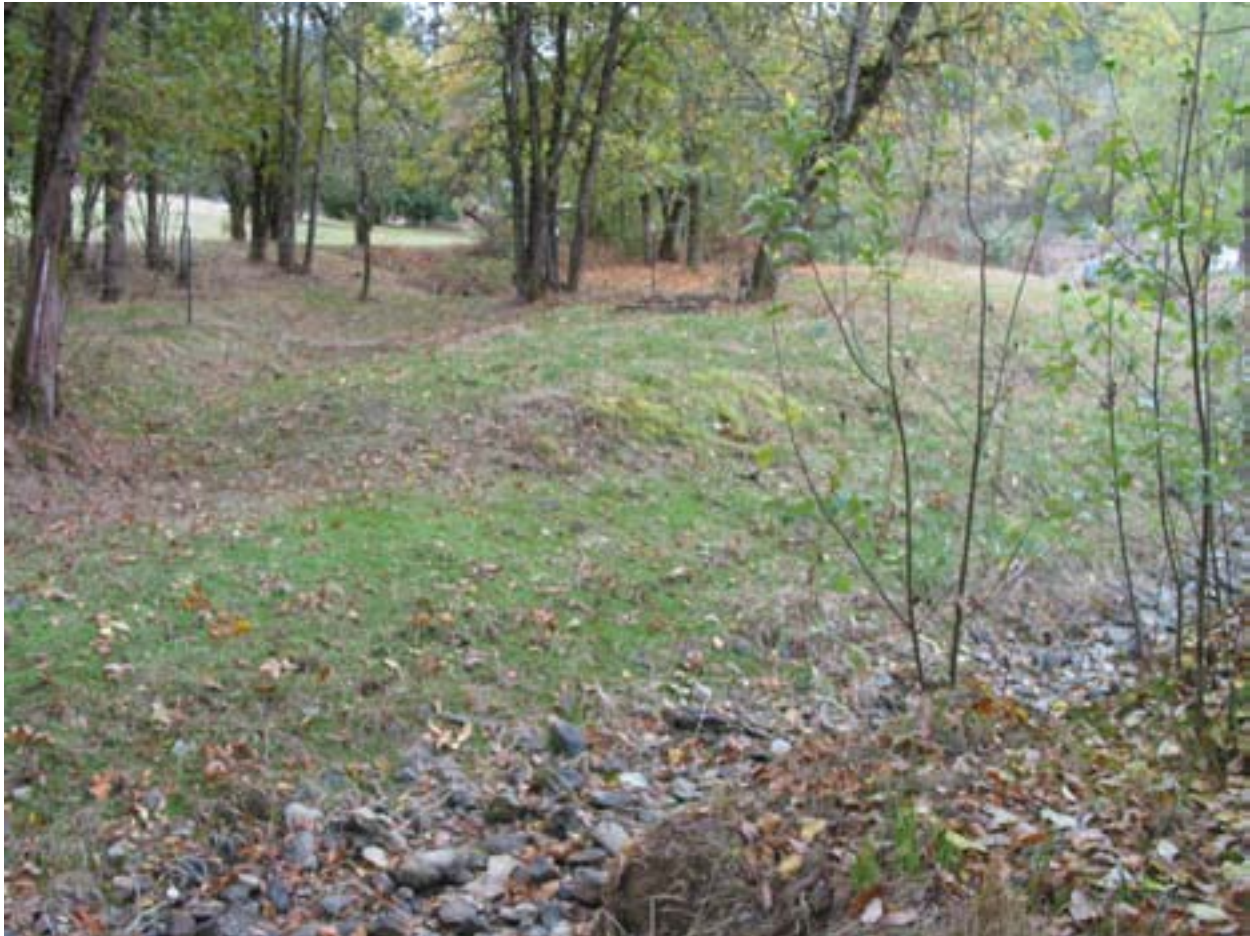
Evidence suggests that Jordan Creek has been modified since settlement times in order to develop and extract resources from the watershed. Miners searching for gold and silver in Jordan Creek in the 1860s re-routed the creek in order to facilitate mineral exploration in the original channel. There is direct evidence of this re-routing in Tax Lot 1100, Section 28, T30S, R5W (the Nunes property). Here, the riparian area along the “new” channel is free of vegetation for some stretches while vegetated with blackberries and annual plants in others. The “old” channel has a narrow, forested riparian area. Figure 36 below shows both channels. In this image, the direction of streamflow is from the background to the foreground.

**Figure 36. Jordan Creek showing evidence of historical channel (left) and current channel (right, with gravel in channel). Latitude = -123.304°, longitude = 42.9271°.**

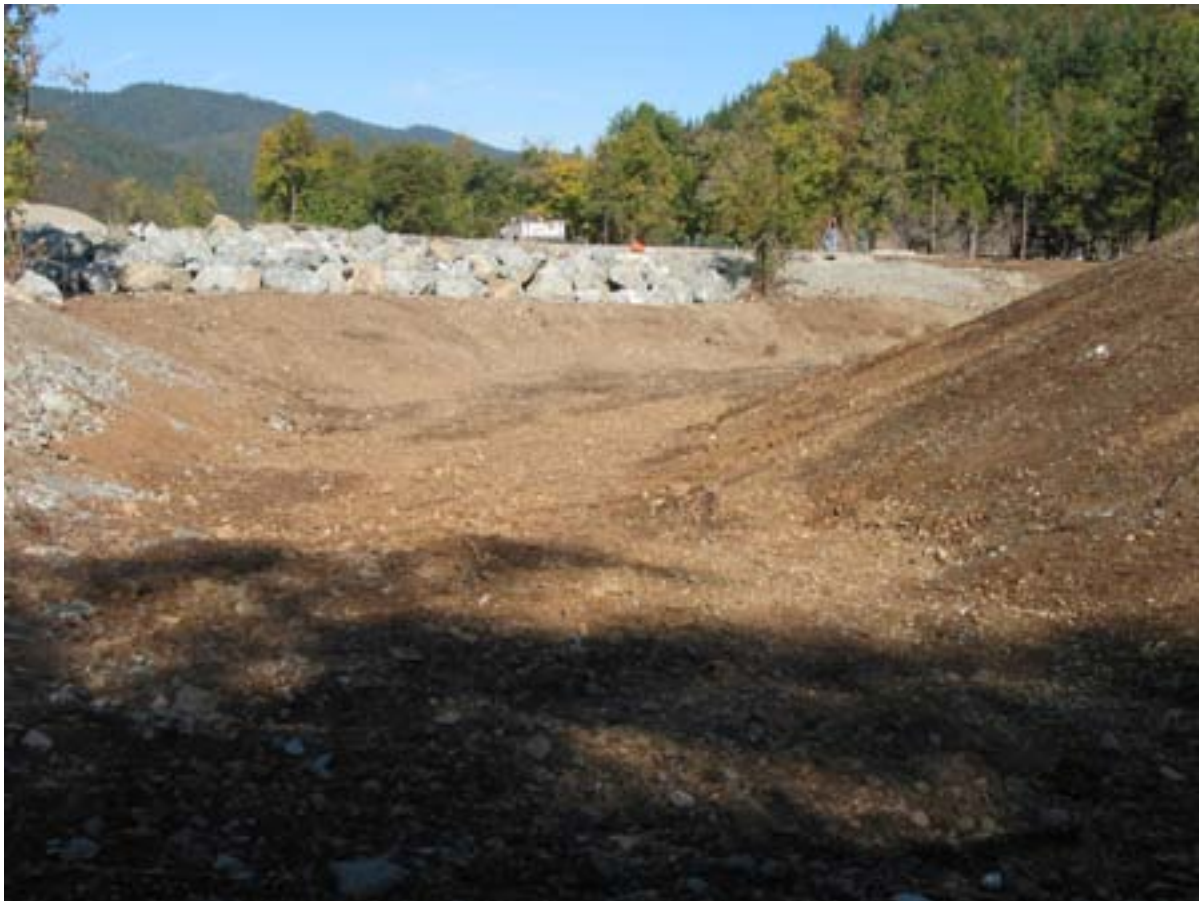
Current RV park development along lower Jordan Creek has also simplified Jordan Creek's channel by removing vegetation and, perhaps, in-channel woody debris. Figure 37 shows a stretch of lower Jordan Creek (upper end of reach 1) just below the upper bridge in the RV park. This is by far the most notable case of channel disturbance in the RV park area. But, the extent of simplification of this reach of Jordan Creek relative to its condition prior to the RV park development is unclear.

**Figure 37. Jordan Creek channel below upper bridge on October 6, 2005.**

It should be noted that, while this riparian disturbance may be significant in the short term, it is anticipated that there will be long-term benefits from the removal of riparian blackberries and other shrubs less desirable from a riparian vegetation standpoint. Also, the RV park development has included the removal of tires, batteries, and other debris from Jordan Creek left over from truck stop operations prior to those of the current Seven Feathers Truck and Travel Center (Jeff Byers, Creekside RV Park Project Manager, personal communication, August 5, 2005).

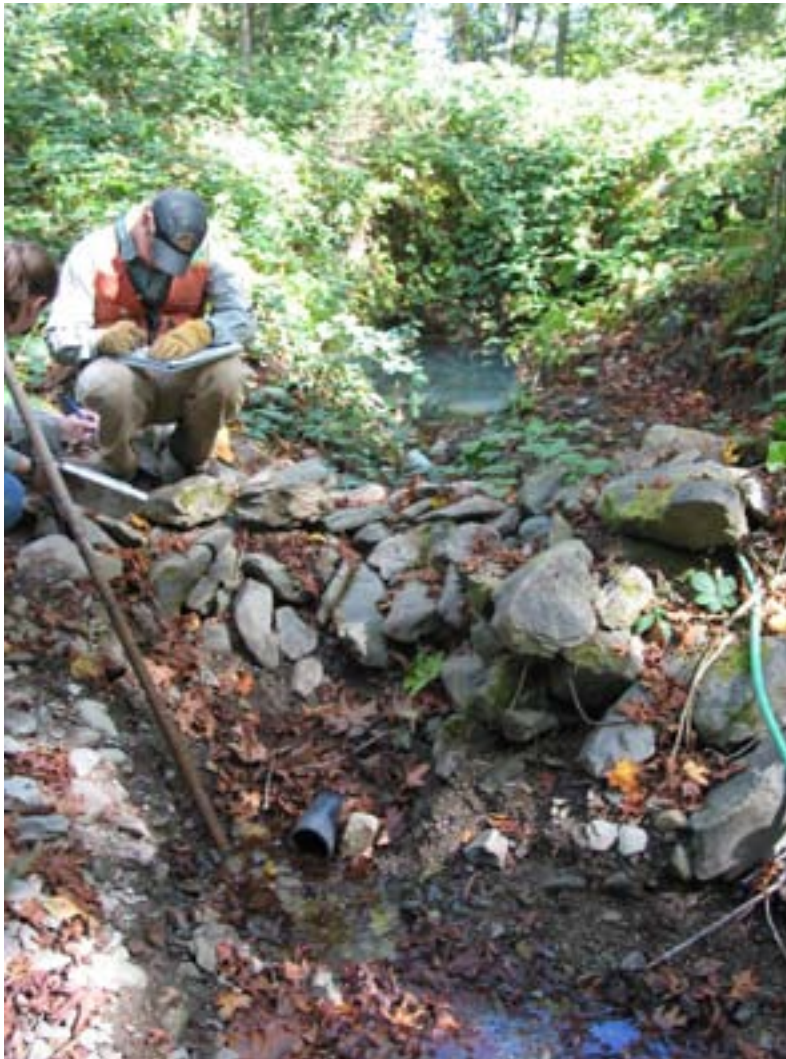
Figure 38 shows what is likely the most significant of the water diversion channel modifications. This diversion is located on Alder Creek. In the figure, Alder Creek runs perpendicular to the short piece of black plastic pipe shown in the bottom middle of the photograph. The gravel diversion structure, routing water through the black plastic pipe, is shown in the bottom left of the photograph, to the left of the wooden staff pole.

**Figure 38. Water diversion on Alder Creek.**

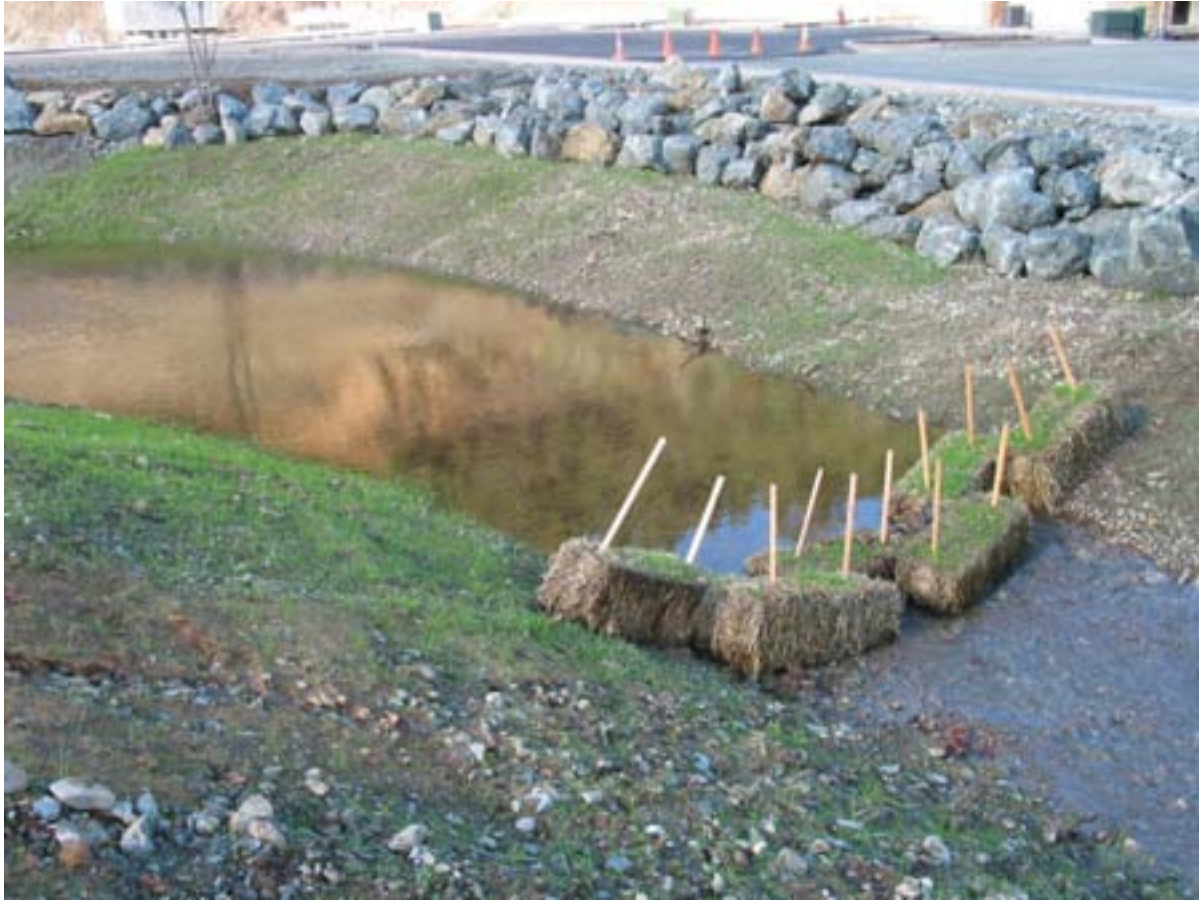
**Figure 39. Jordan Creek on November 14, 2005, looking upstream toward upper bridge in Creekside RV Park.**

6. Place large woody debris in the lower half of Jordan Creek Reach 1 specifically to capture gravels to improve spawning habitat and add roughness to the stream channel. Note the pooling effect and the beginning of spawning habitat riffle creation taking place in Jordan Creek Reach 1 below bridge #3 in the Creekside RV Park as shown in Figure 39 below. For comparison, Figure 37 shows the same stream stretch six weeks earlier, prior to the onset of fall rains.

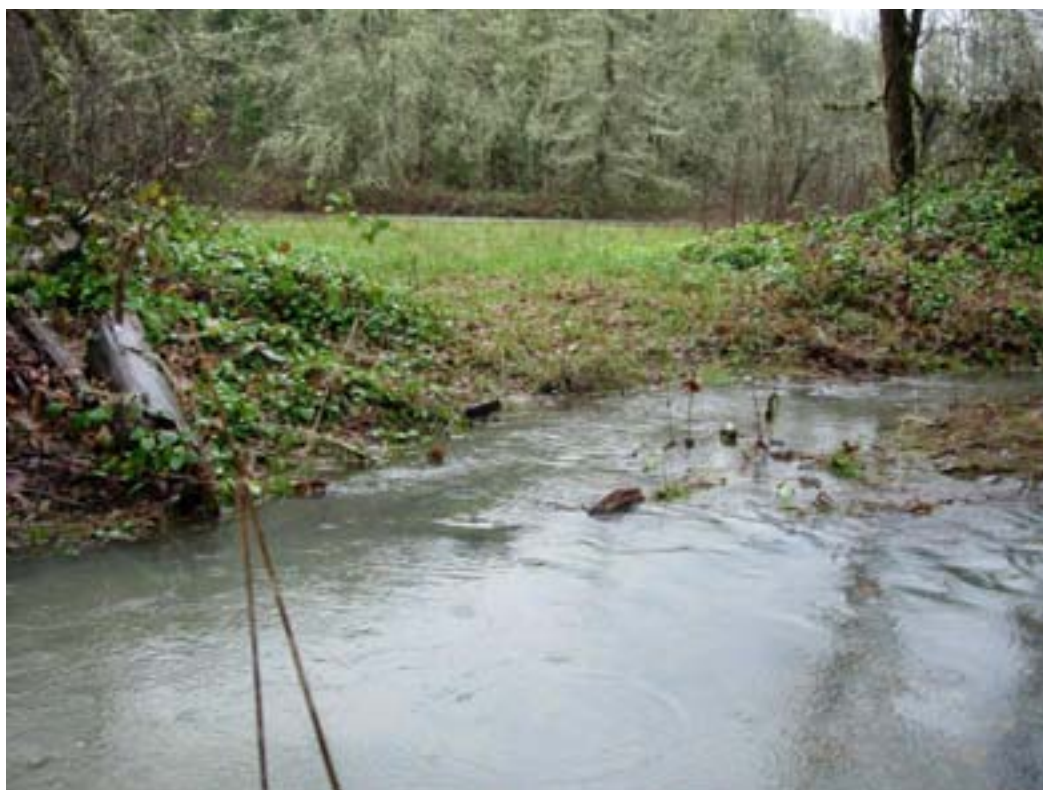
**Figure 45. Point of Jordan Creek overflow onto Rod & Gun Club parking area.**

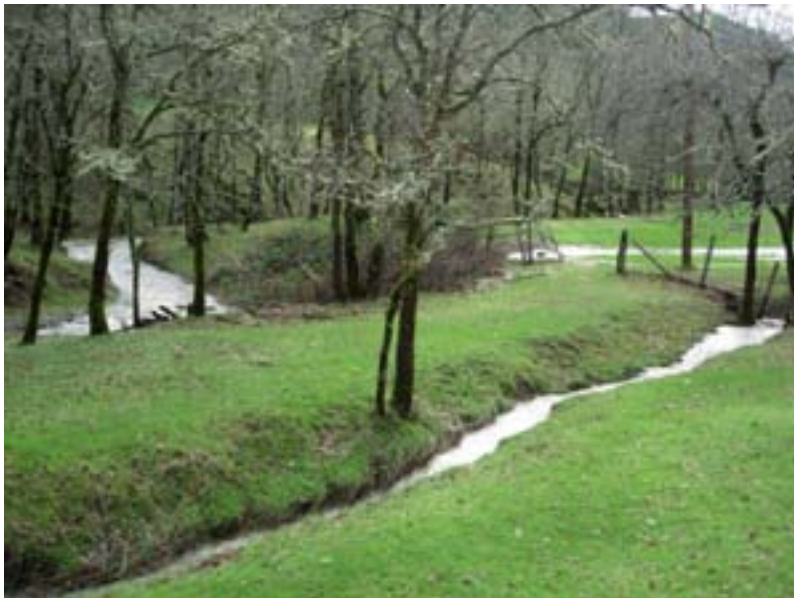
3. The “Nunes” secondary channel in Tax Lot 1100, Section 28, T30S, R5W may provide an opportunity to develop a secondary channel on Jordan Creek to divert flow during high streamflows and reduce streamflow velocity during heavy winter flows. This secondary channel is the “historical channel” shown in Figure 36 and discussed in Section 3.2.3. The secondary channel could be filled with backwater created by increased hydraulic resistance in the current Jordan Creek channel.

**Figure 48. “Nunes” rearing pool development opportunity (background right) and augmentation stream (foreground), with Jordan Creek on left.**

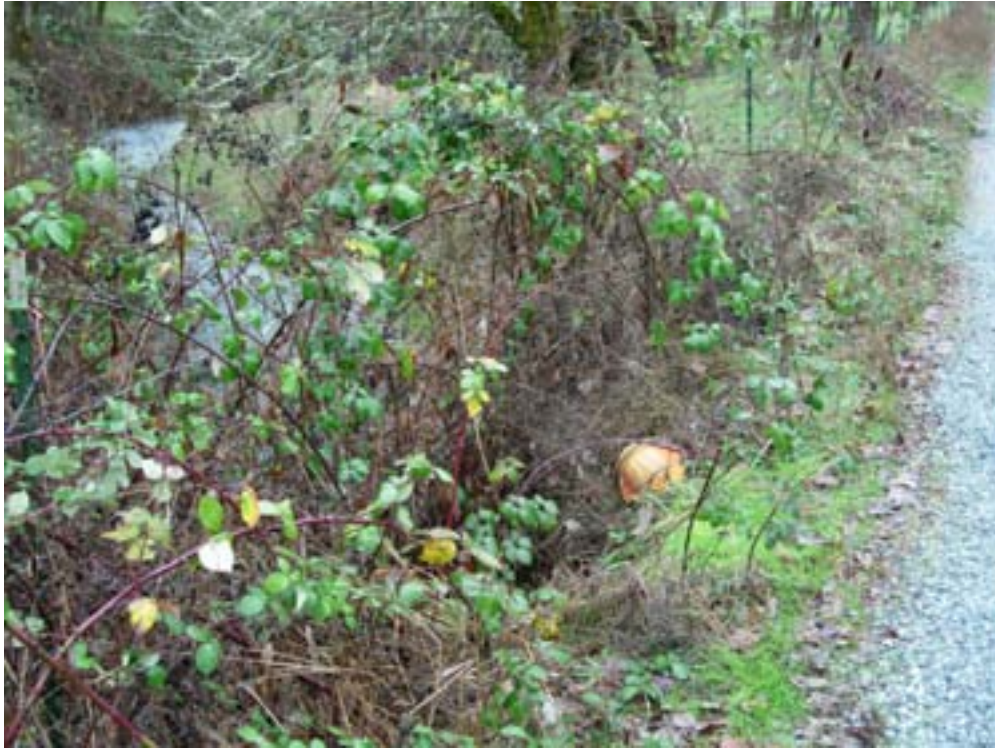
**Rural Road Runoff.** The earlier section on “Road Instability” addresses the potential sediment delivery from roads near streams. Much of the Rod & Gun Club Road is within 70 feet of Jordan Creek (see Figure 51). There are several locations along this road where the road is located at the top of a steep streambank along the creek. Figure 54 shows one such location near Tax Lot 1100, Section 28, T30S, R5W (the Nunes property). During past periods of high streamflows, the creek has eroded away the road, creating sediment immediately input to Jordan Creek.

**Figure 54. Rod & Gun Club Road adjacent to Jordan Creek.**

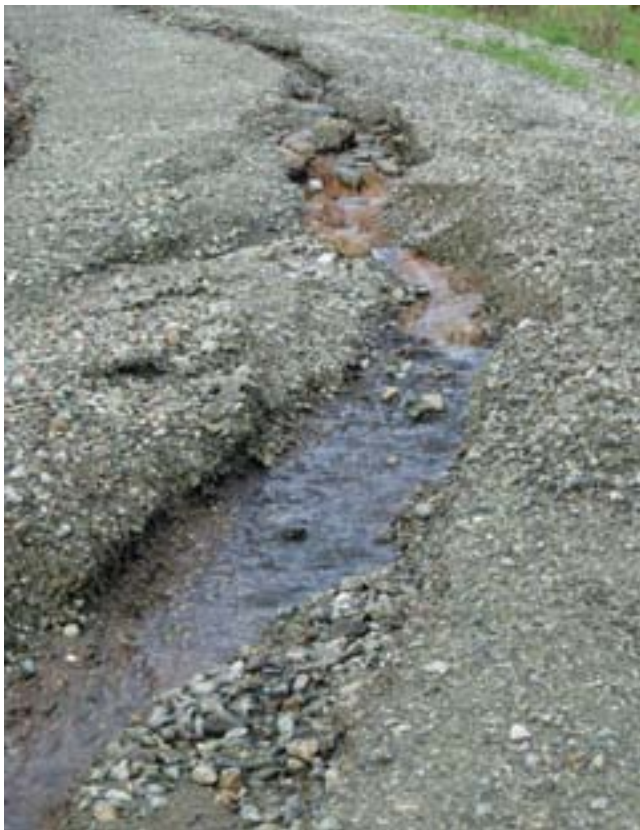
**Figure 55. Erosion from driveway in Jordan/Alder Watershed.**

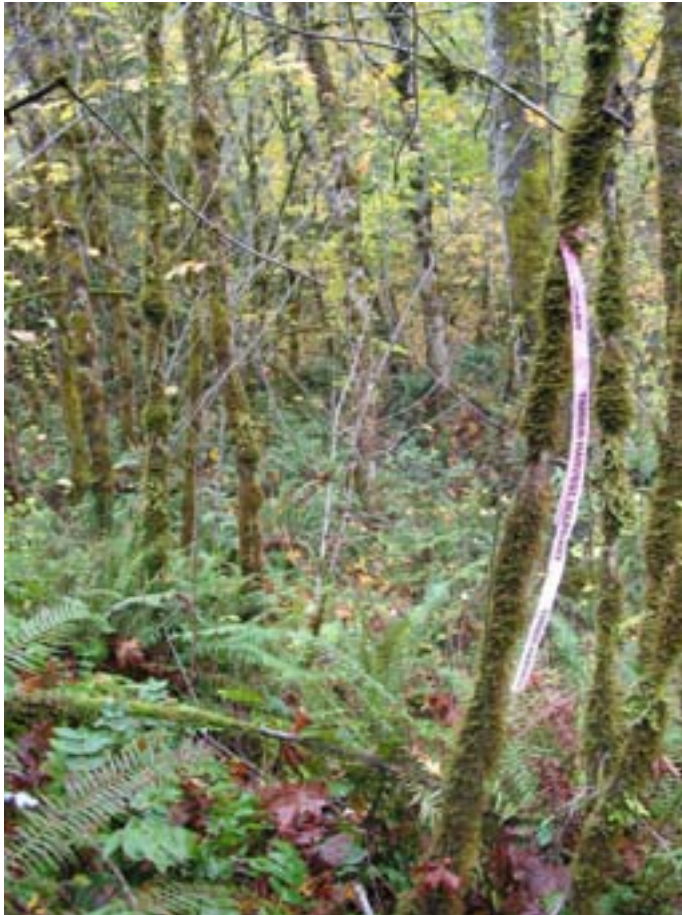
The FPA requires protection of streams and riparian areas during road construction, timber harvest, and other forest operations. RMA rules, including zones of protected vegetation and other requirements, require protection on fish-bearing, domestic use, and some other streams. Figure 56 shows an RMA on Alder Creek after an adjacent clearcut harvest.

**Figure 56. Alder Creek riparian management area after adjacent timber harvest.**
